Heritage Assessment

Longtown Outdoor Education Centre Longtown Herefordshire HR2 OLD

Longtown Outdoor Learning Trust

September 2022

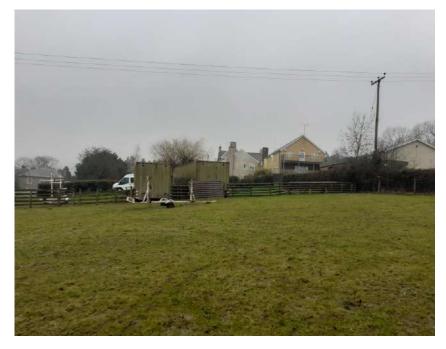
Plate 1: View looking SW across land to rear of the Longtown Outdoor Education Centre

Several site visits were undertaken to ascertain potential impacts on heritage assets both in the immediate and wider vicinity of the site. The site of the proposed new dining facility is located within the NW corner of a large irregularly shaped pasture field (at about 169m AOD) to the rear of the Outdoor Centre and the adjoining complex of modern classroom buildings (*Plate 1*). Two modern containers are located against the W boundary of the field.

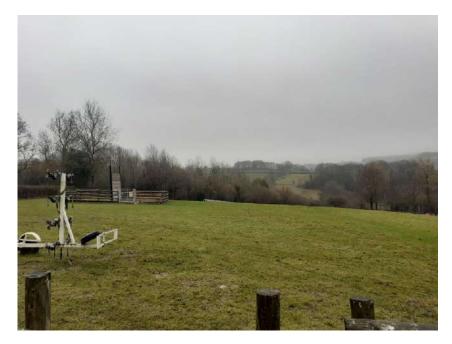
Plate 2: View looking ENE across NW corner of field to E of the Outdoor Centre

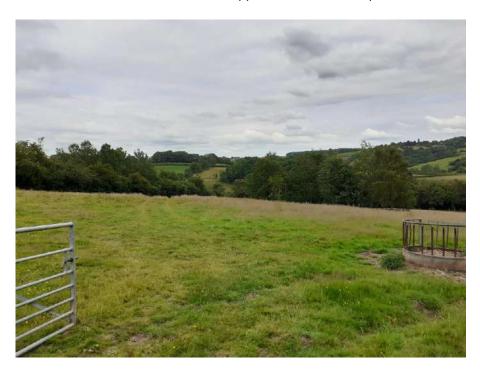
Plate 3: View looking E across pasture field to E of Outdoor Centre

The eastern portion of the field gradually descends towards the River Monnow and there are extensive views looking E towards the upper eastern slopes of the Monnow Valley (*Plates 2-4*), consisting of a landscape of pasture fields defined by heavily tree-lined hedges interspersed with discrete tracts of woodland, with occasional distant glimpses of farmsteads and outlying farm buildings on the upper slopes. Views are partially limited by a small bank of coniferous trees within the centre of the field which appears to be a recent plantation.

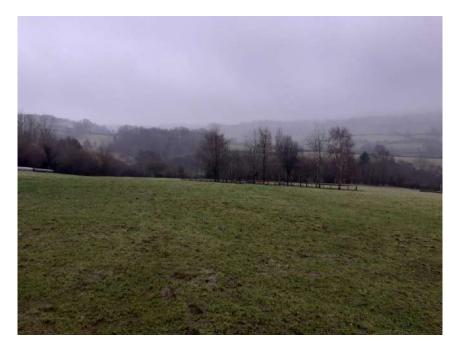
Plate 4: View looking ESE across pasture field to E of Outdoor Centre, showing modern plantation

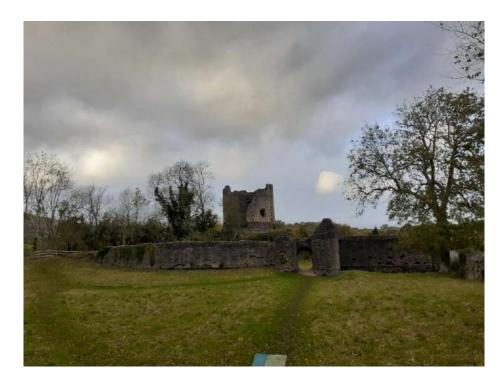
Plate 5: View looking NW from the outer bailey towards the inner bailey gatehouse, curtain wall and circular keep at Longtown Castle

The following description of Longtown Castle and Town is chiefly based on the Scheduling description contained in the National Heritage List (List Entry No. 1021347) and informed by the results of recent survey work and archaeological investigations (Smith 2003; Hoverd 2018). The Scheduled Monument comprises a motte and bailey castle with associated earthworks and settlement remains lying on a spur at the confluence of the River Monnow and Olchon Brook in Herefordshire, overlooked by the Black Mountains close to the border with Wales. The castle and earthworks comprise a linear development running north west-south east and lie in four separate areas of protection. At the north west end is a keep, located in the north west corner of the inner bailey (*Plate 5*). The inner bailey, in turn, lies in the north west corner of the outer bailey, which is now bisected by the modern road (*Plates 6 & 7*).

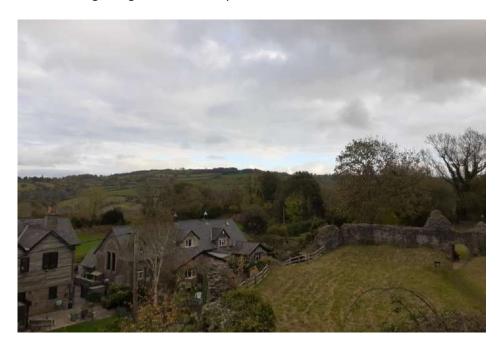
Plate 6: Elevated view looking SE from the castle keep across the inner and outer baileys (with the Victorian former School House to left of picture) towards the site of the Outdoor Centre, hidden by a mature tree screen

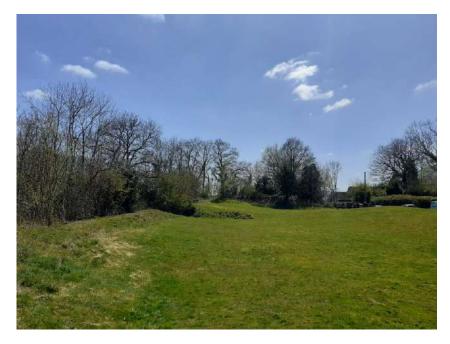
Plate 7: View SSE across the eastern portion of the outer bailey (previously used a village green) with the Outdoor Centre concealed by existing tree lined banks

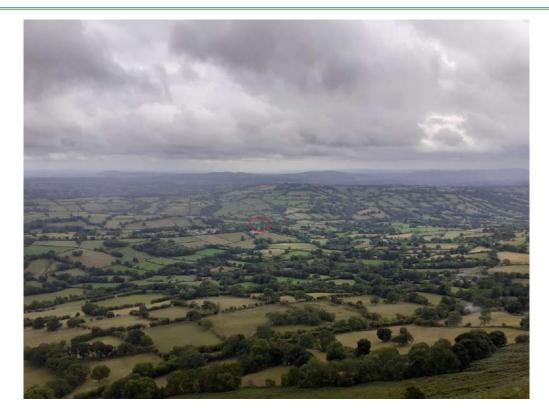
Plate 8: Elevated view looking E from Hatterrall Ridge towards the village of Longtown, clearly showing its historic linear form (with approximate site circled in red)

Its linear form remains highly legible both in terms of views looking along the main street of Longtown and longdistance, elevated views looking from the Hatterrall Ridge to the W and the Ewyas Harold road to the E (*Plates 8 & 9*). These long-distance views are particularly important as they eloquently illustrate the historical role of Longtown as a frontier settlement, dominated by the remains of its imposing castle and framed against the Black Mountains to the west, demarcating the historically turbulent border with Wales.

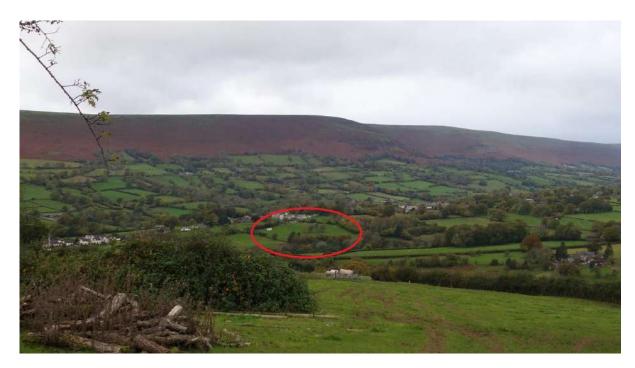
Plate 9: Elevated view looking W towards Longtown from the field gate on the Ewyas Harold road, between Lower Bryn and Bryn Farm, with the proposal site to the rear of the Outdoor Centre visible (circled in red)

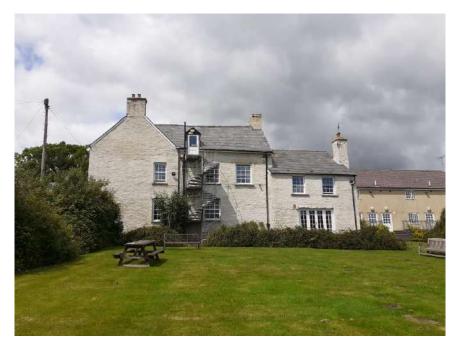
Plate 10: View NW towards the Grade II listed Outdoor Centre (formerly the New Inn) with modern extension visible to rear

The principal west-facing elevation of the building has two 20th century gabled dormers with three-light casement windows, with three 6 × 6 sash windows at first floor level and two 6/6 sash windows at ground level flanking either side of a gabled porch with a timber superstructure resting on dwarf stone walls (*Plate 11*). A partially mutilated stone plaque to left of window on the first-floor bears inscription with name "New Inn". The interior of the building has been much altered but retains some original features including a late 18th/early 19th century dog-leg staircase with turned balusters.

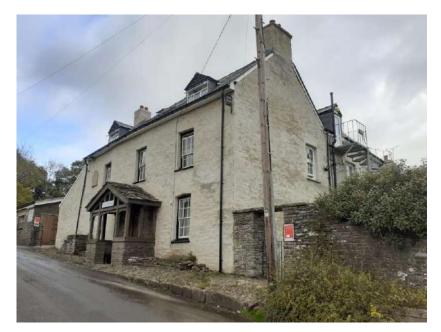
Plate 11: View looking N towards the principal front elevation of the Outdoor Centre (formerly the Mountain Centre, formerly known as the New Inn), a Grade II listed building

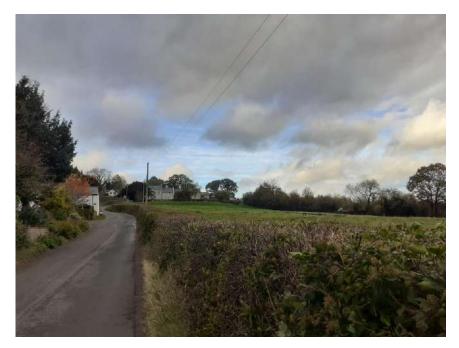
Plate 12: View looking N from the main street towards the Outdoor Centre showing the Scheduled settlement earthworks in foreground, the proposal site is largely screened by an existing tree-lined hedge boundary to the S (to right of picture)

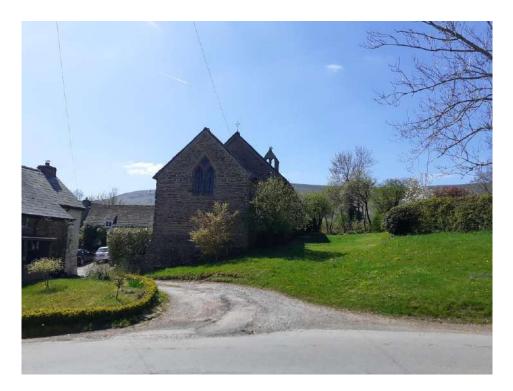
Plate 15: View SW towards former parish church of St Peter from main street opposite entrance to Outdoor Centre car park

Sited on a slightly raised slope overlooking the main street and the Outdoor Centre to the E is the former parish church of St Peter's (*Plate 15*). The church appears to have been established in the 12th century as a chapel of ease to Clodock; the existing building dates back to the 13th century and was substantially restored in the 1860s; it was converted into a private house in 1983-4.

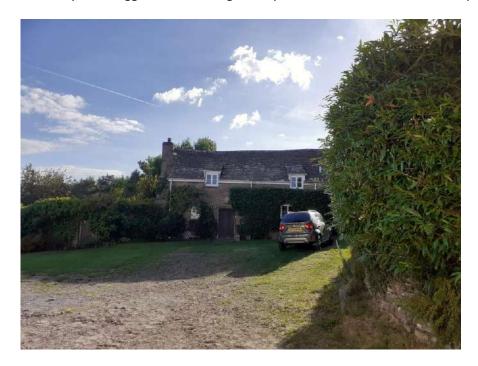
Plate 16: View looking SW towards Sun Inn Cottage, to S of former parish church

Located about 5m S of the former parish church of St Peter is Sun Hill Cottage (*Plate 16*), comprising a single storey dwelling with attic, of sandstone rubble construction with a stone slate and Welsh slate roof (List Entry No. 1067711). The core of the building, which was used as an inn during the 18th and 19th centuries, appears to be of early 17th century date but remodelled during the 18th century; it is rectangular in plan with a probable through-passage, with a S gable end stack (incorporating a stone winder staircase) with a lateral stack to the west front. The interior retains traces of a square panelled timber framed internal partition and a heavy beam in the room to the right of the entrance on the E front of the cottage, as well as evidence of a malt kiln and a bake oven in the kitchen. Although the existing cottage appears largely to date from the 17th century, the survival of a door jamb of late 15th/early 16th century date suggests that its origins may date back to the late medieval period.

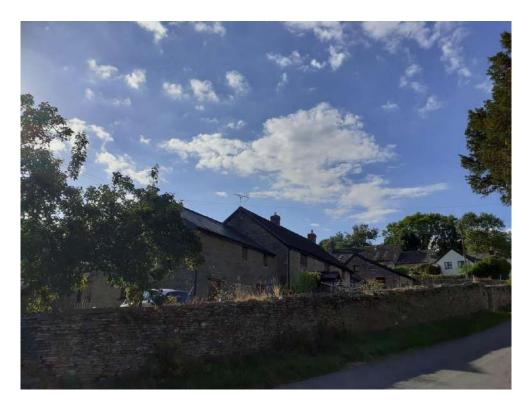
Plate 17: Oblique view looking NW from the main street towards The Ferns

Located on the W side of the main street roughly opposite the Outdoor Centre is The Ferns, a Grade II listed house of late 17th or early 18th century date, with 20th century alterations and additions and recently sub-divided into two dwellings (List Entry No. 1067683). The main house is of two-storeys, rectangular in plan (aligned NW-SE) and of sandstone rubble construction with a 20th century tiled roof, while attached to the NW end is a single-storey service wing with a stone slate roof (*Plates 17 & 18*).

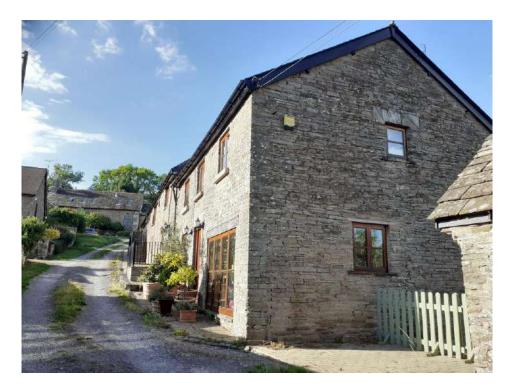
Plate 18: View looking N showing rear elevation of The Ferns, with former church of St Peter's visible in background

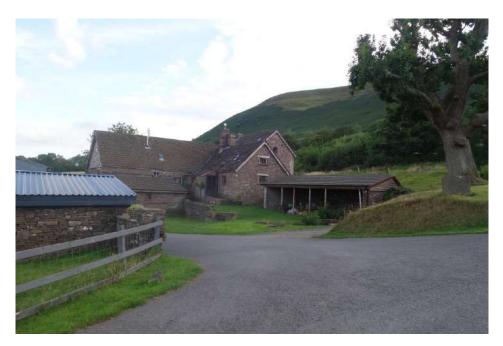
Plate 19: View looking SE from Mountain Road towards Great Turnant farmhouse

Great Turnant is a substantial Grade II listed farmhouse situated in an isolated, steeply sloping setting on the Mountain Road to the W of Longtown, about 1.6km W of the site (*Plate 19*). The farmhouse, which is designated as a Grade II listed building (List Entry No. 1078179) comprises a late 15th/early 16th century core (possibly timber-framed), remodelled in the 17th century with further alterations made in the 20th century.

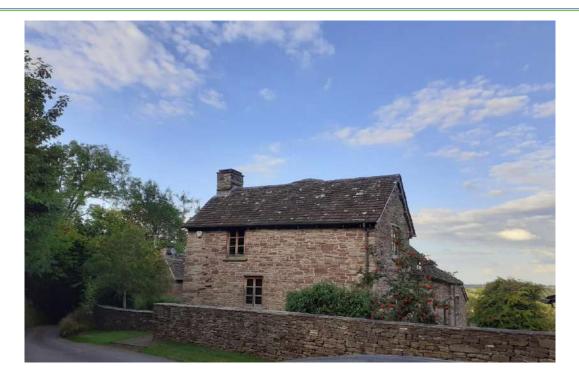
Plate 21: View looking W from Mountain Road towards exterior of Lower Turnant farmhouse

Located about 1.5km WNW of the proposal site is Lower Turnant, Grade II listed L-plan farmhouse occupying a steeply sloping site on the Mountain Road W of Longtown (*Plates 21 & 22*). The farmhouse appears to have originated as timber-framed structure of late medieval date with a two-bay cruck hall and a half-timbered two-storey solar cross-wing above the hall to SW. Internal evidence of the original cruck-framed roof structure survives in the hall and the roof structure of the solar wing has survived largely intact. At some point during the early 17th century, it appears that the farmhouse was extensively remodelled and rebuilt in stone, represented by the existing chimney-stacks and their fireplace stairs, the stone walling of the hall and the insertion of an upper floor; the walls of the cross wing were later rebuilt in stone during the 18th/19th centuries.

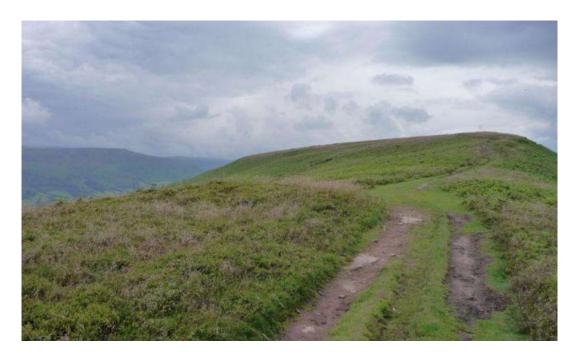
Plate 23: View NW towards Rhiw Arw cairn adjacent to the Offa's Dyke Path on Hatterrall Ridge

Located about 2.5km SW of the site, adjacent to the Offa's Dyke Path on Hatterrall Ridge (on the border between England and Wales) are the heavily overgrown remains of a round cairn of probable Bronze Age date at Rhiw Arw, which is designated as a Scheduled Ancient Monument (Cadw SAM Ref. MM299). The cairn is situated within open moorland on the summit of the narrow ridge extending N of Hatterall Hill (*Plate 23*), with panoramic, distant views to the E and NE across the Monnow and Olchon valleys towards Longtown (*Plate 24*) and to the NW across the Vale of Ewyas. The grass and heather-covered stony cairn is circular on plan and measures 7m in diameter and about 0.5m in height.

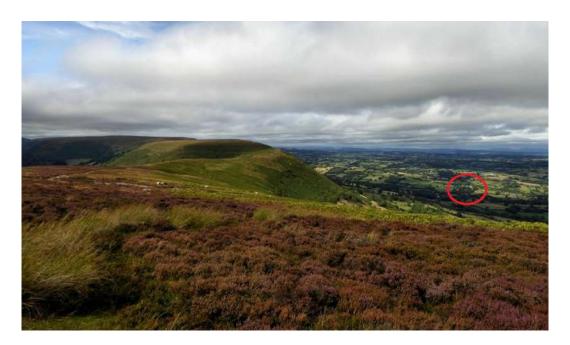
Plate 24: View NE from Hatterrall Ridge showing Rhiw Arw cairn (to left of picture adjacent to Offa's Dyke Path) with distant views looking across the Olchon Valley towards Longtown (to right of picture)

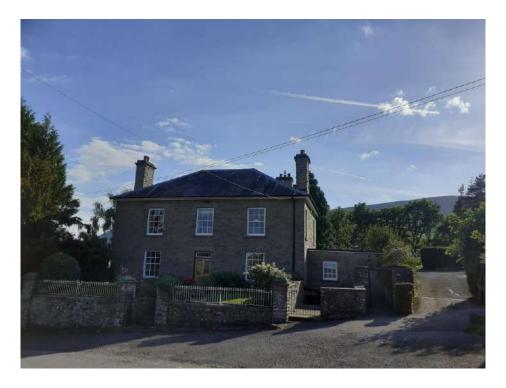
Plate 25: View looking WSW towards Castle Lodge, of mid-late 19th century date

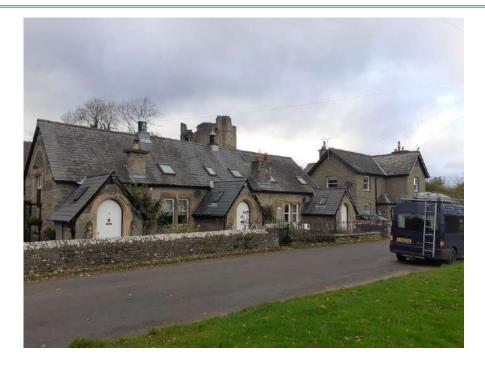
Plate 26: View looking W towards the old School House (built in 1868-9) and the adjacent former master's house (1902), overlooked by the keep of Longtown Castle

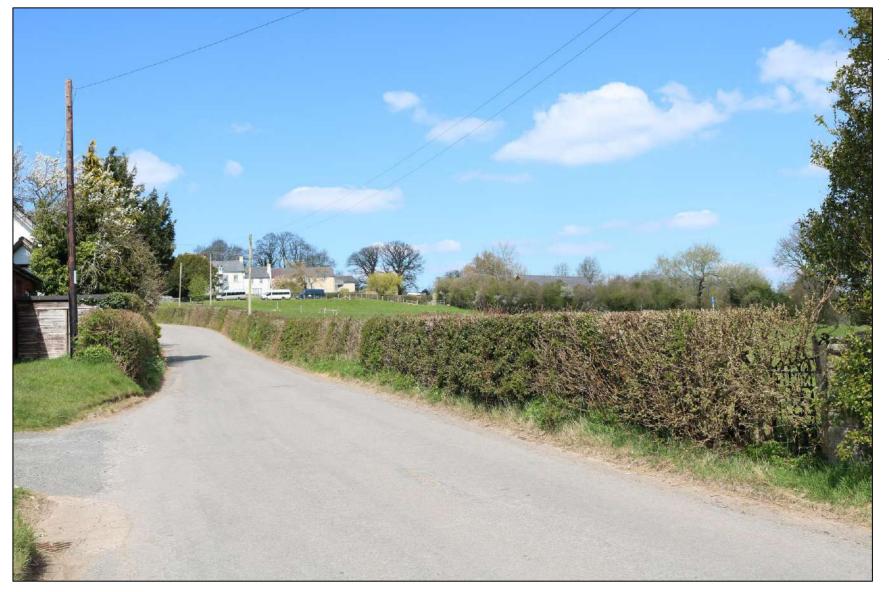
Fig. 16 Rendered visual looking N from main street towards Outdoor Centre showing roofline of New Building

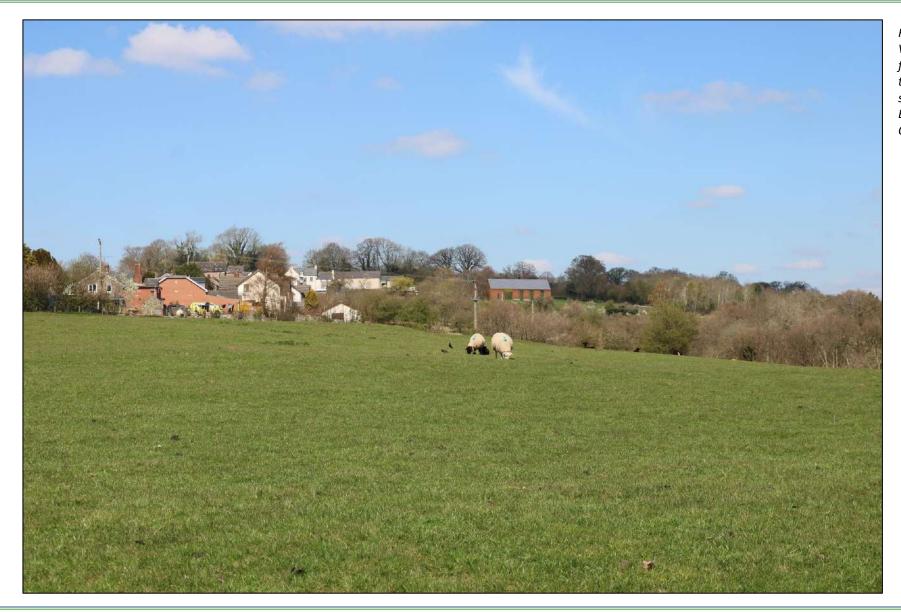
Fig. 17 Rendered Visual looking N from pasture field to W of main street showing New Building to rear of Outdoor Centre

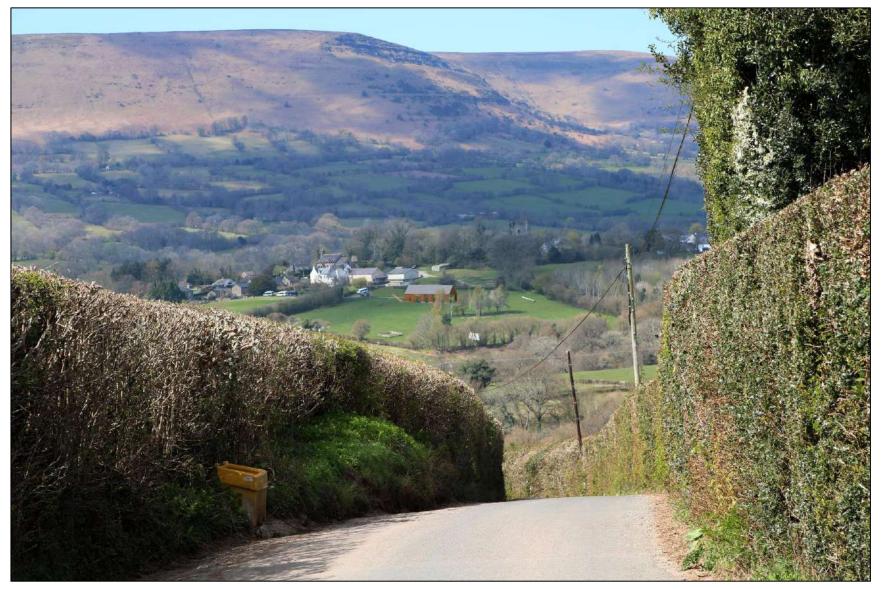
Fig. 18 Rendered visual looking W from Ewyas Harold road above Pont-yr-ynys showing New Building to rear of Outdoor Centre

From these vantage points, there are glimpsed, partial views of the village (notably excluding the castle which is concealed by existing landform and tree cover) and the rear portion of the Outdoor Centre, the roofline of the proposed new building would feature in these views, standing slightly apart from the main complex and rising slightly above the existing treeline. However, it is considered that the impact on wider views of the Scheduled Castle and Town from these particular vantage points would be limited and largely restricted by existing tree cover, although it may be noted that the bell turret of the former parish church of St Peter would be visible in the backdrop to these views just above the roofline of the Outdoor Centre.

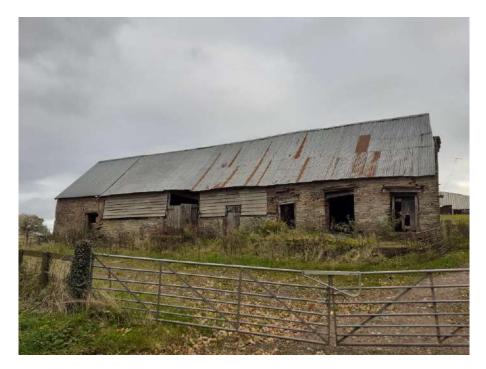
Plate 27: Example of a Grade II listed detached 17th century barn with cow shed, 40m E of Cwmbologue Farm near Longtown

plan farmsteads, where there are detached barns or loose groupings of outbuildings set apart from the farmhouse, such as those at Cwmbologue (*Plate 27*) and Old Bryn Farm to the E of Longtown (Lake 2020).

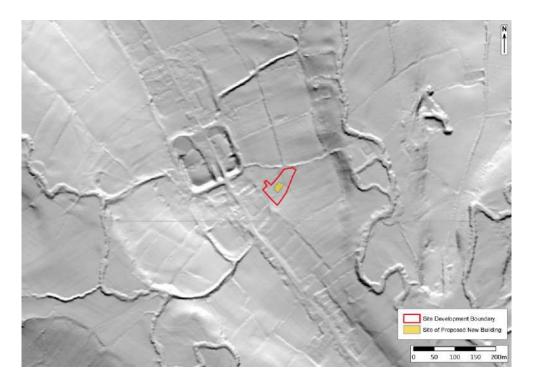
Fig.24: Extract from LiDAR 2m DTM Data (Reproduced by courtesy of the Environment Agency)
