## THE SEARCH FOR EWYAS HAROLD PRIORY

*Season Two*

*for Ewyas Harold Archaeology and History Group*

*March 2012*

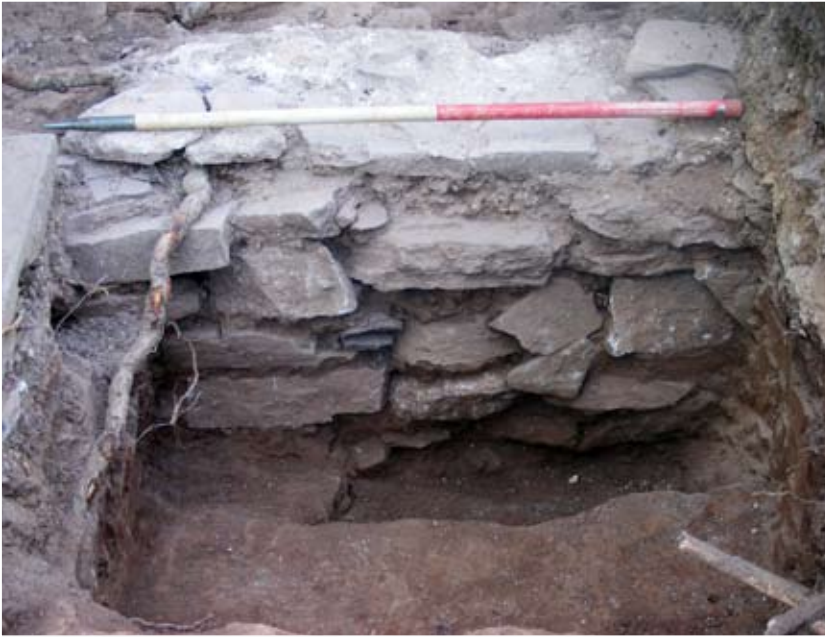
◀ Illus 4

*Northern wall of nave, context 119*

As seen in the excavation (Illus 4), the nave appeared to be a simple structure with only one main phase of construction. The north wall of the nave (Illus 5; 119) was revealed in Trench 1. It was 1.25m wide and approximately 0.70m deep. It consisted of a foundation, constructed of sandstone blocks of varying sizes (Illus 3). The top of the wall appeared to be narrow strip of flat stone and white mortar measuring 1.25m x 0.55m and running into the western section. No return wall for this section was revealed.

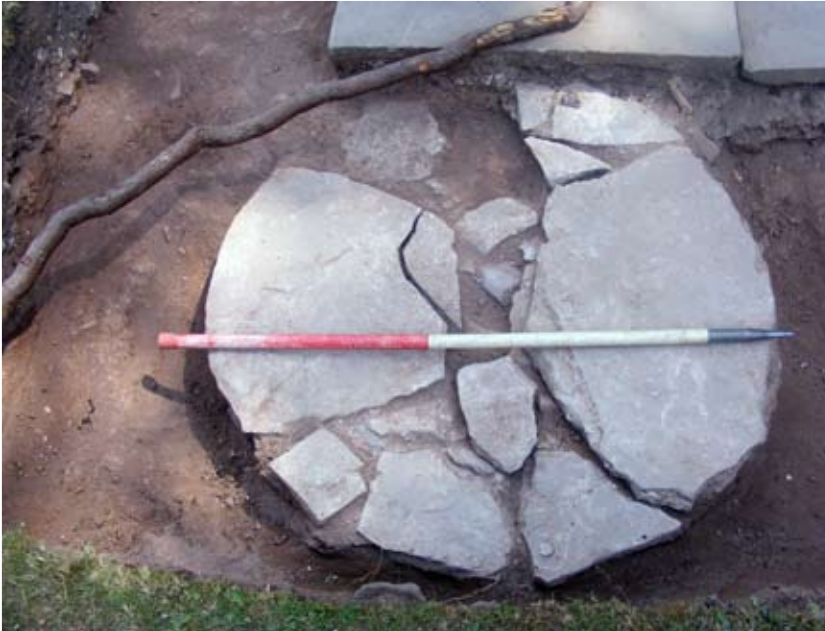
◀ Illus 5

*Font base, context 117*

A broken circular stone feature [117] with a diameter of 1.06m was uncovered in at the north end of Trench 1 (Illus 6). It appeared to have a rectangular slot in the centre (Illus 4) and may have been a font base.

| Context no. | Trench no. | Description | Dimensions (m) |
|---|---|---|---|
| 117 | 1 | Circular stone at northern end of trench. Broken into smaller pieces. Rectangular [0.035 x 0.11] hole in the centre may indicate something slotted into the top. Within rubble 104. Font or column base? | L: 1.07<br>W: 1.03<br>D: 0.11 |

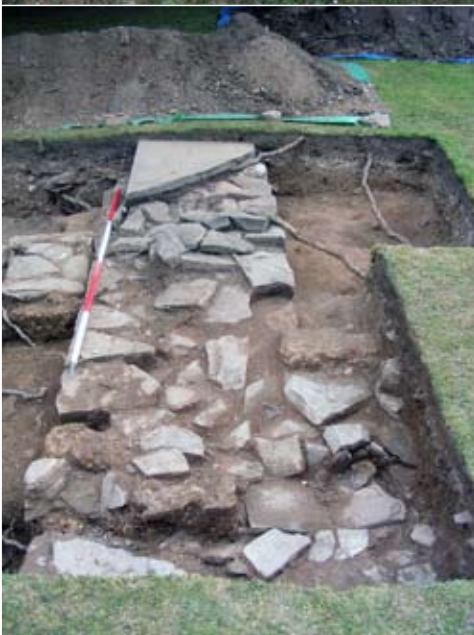
◀ Illus 6

*Eastern wall of nave, context 215*

A portion of the east wall [215] of the nave and its return to the west was revealed in Trench 2 (Illus 7). It measured 3.25m north-south and 1.35 east-west (Illus 5, Illus 11). It was approximately 1.05m wide and the excavated depth was 0.50m. It was constructed of sandstone and was rendered on the eastern and western faces. On the eastern side foundations, projected approximately 100mm from the face. Tufa was used in the quoins and a break in the construction at the southern end terminated with a tufa

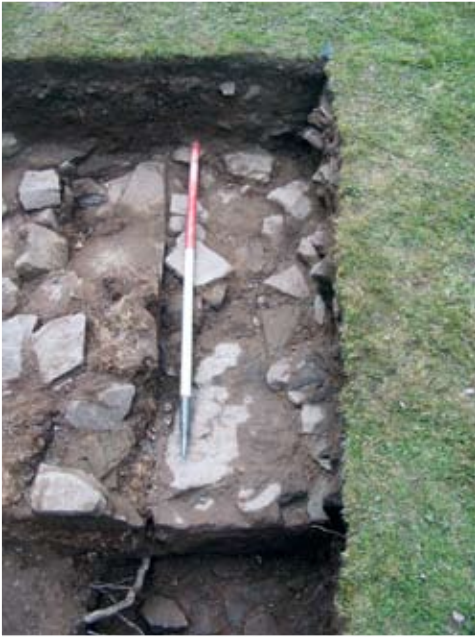
◀ Illus 7

*Possible ancillary building or buttress, wall 244*

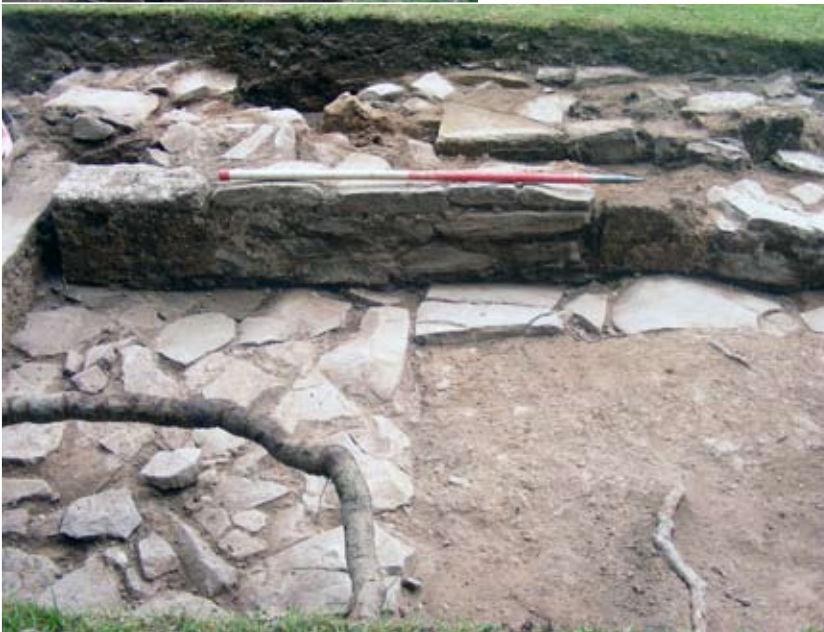
◀ Illus 8

*North wall of chancel (212) and eastern wall of nave (215)*

In this phase it is certain that the chancel and the nave formed a structure of contemporaneous build. The earlier apsidal end (wall 256) appears to have been replaced by a second apse (wall 209). The northern wall [212] of the chancel butted against the eastern face of the nave (Illus 9) and was constructed of sandstone with a W of 0.80m and depth of 0.20m. As in the nave, the wall contained tufa quoins where it abutted other structures and at corners, and these may have been placed to show off architectural features. The foundations projected about 100mm from the wall base. The adjoining apse end (wall 209) was also constructed of sandstone with tufa blocks apparently deliberately placed. It was three courses deep and approximately 0.25m wide. The position of this apse appears to have created a broader entrance to the sanctuary than seems to have been present in the earlier phase. Within the interior of the apse in this phase was a compact silty deposit (220) containing no finds or chancel, but which appears to have been a floor surface.

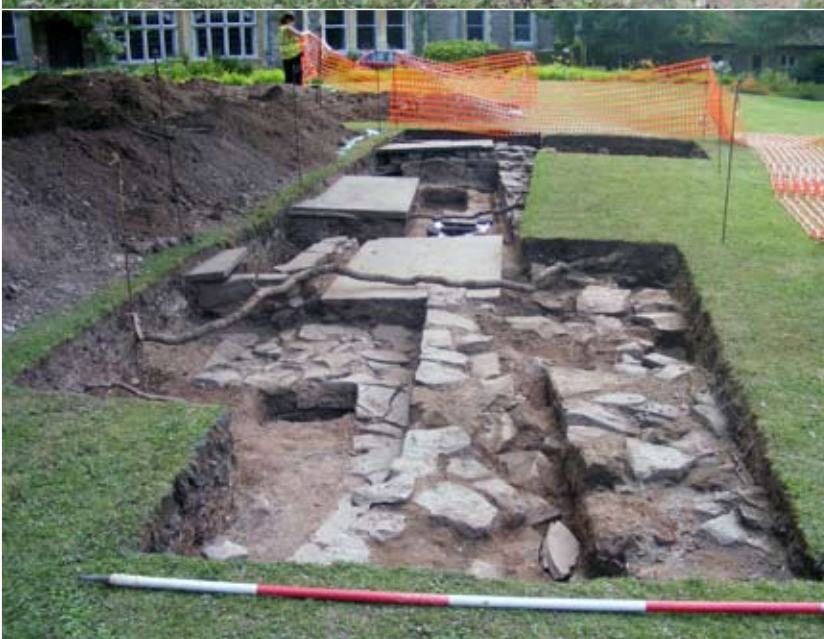
◀ Illus 9

*Wall 251 squaring off the apse*

Wall 251 was exposed running along the northern edge of trench 2. It was revealed only in plan and appeared to be of a rough construction. Although it contained occasional tufa blocks, these did not appear to be deliberately placed as in the previous phase and the build of the nave. It may have been built from re-used stone. Rubble filled the space between wall 251 and apse wall 209, and the outer face of wall 209 appeared to have been destroyed by the construction of wall 251 (Illus 10). Wall 251 appeared to but against the east end of wall 212, but some disturbance had been caused in this area, possibly by the partial demolition of wall 209.

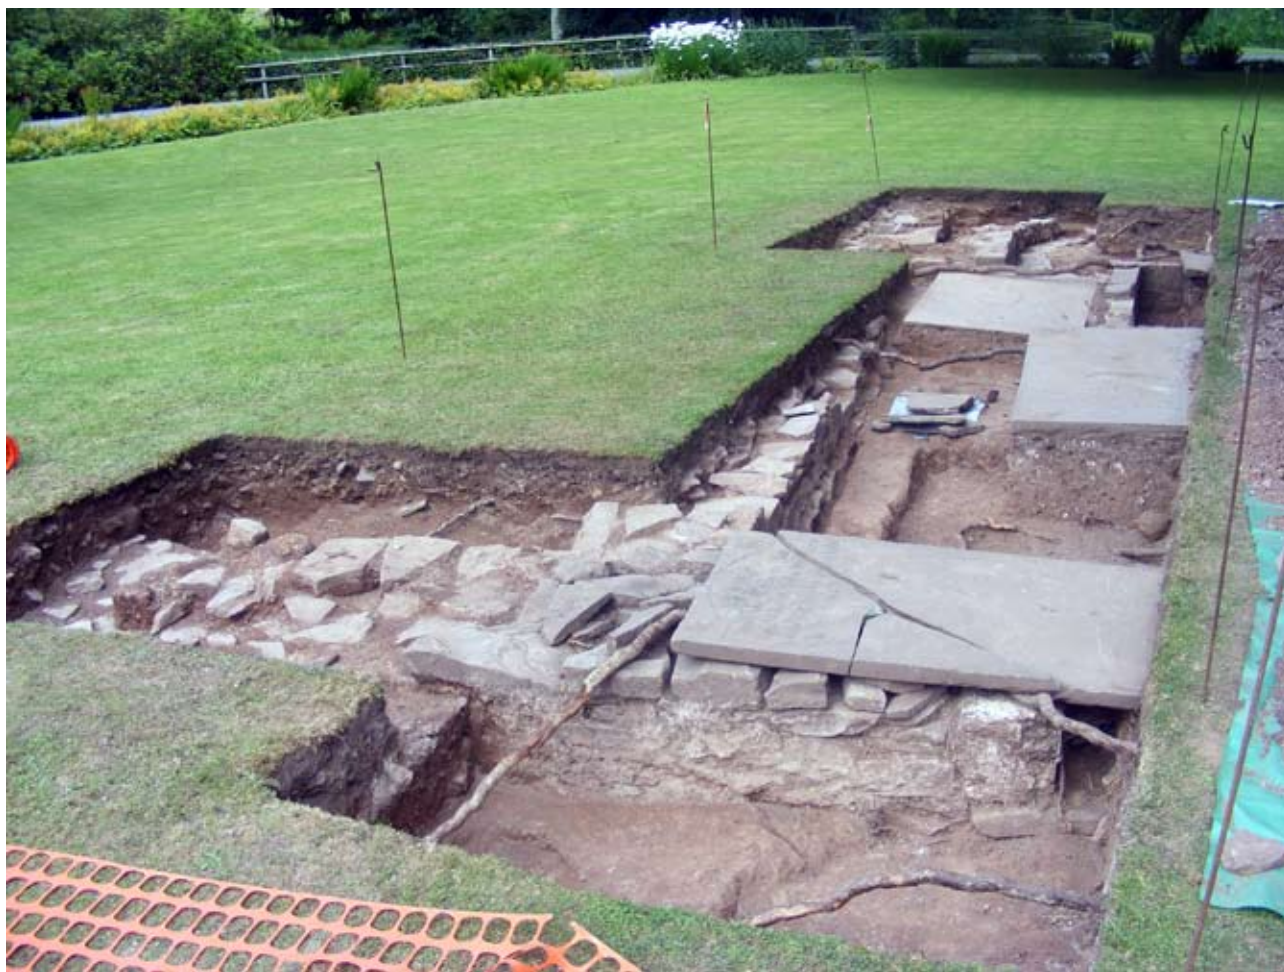
Illus 10

Grave slabs in Trench 2

The earliest contexts dating to this period in Trench 2 (Illus 11) were a number of grave slabs (contexts 202, 203, 205 and 206) dating to the later 18th or early 19th centuries. Two of these were fragments of larger stones. The memorial to Ann, the wife of John Williams (slab 202), who died in 1780, was incorrectly aligned (ie north/south) and overlay the top of wall 215 at the eastern end of the nave. An early stone possibly of 17th century date (204) overlay a later one (203) dated to the later 18th century demonstrating that it too had been moved from its original position. These stones commemorated the Jones family and may have been grouped together for this reason. Dates at the end of the 18th century suggested that surviving members of these local families may have wished for the stones to remain in place when the church was demolished or that it was not considered practical to remove them to the site of the new church.

Wear and repair on the ledger memorial to Thomas and Sybill Jones (1749 and 1759) and their son John, who died in 1799, demonstrated that it had been used as a surface in either a path or within the church. The wear on this stone was considerably greater than that on other memorial stones recorded during the excavation and which were of broadly similar date. Although correctly aligned it is unlikely to have been in its original position as its surface was lower than the upper course of the shaft grave, otherwise the floor must have been raised in the short interval between the death of John and the demolition of the parish church.

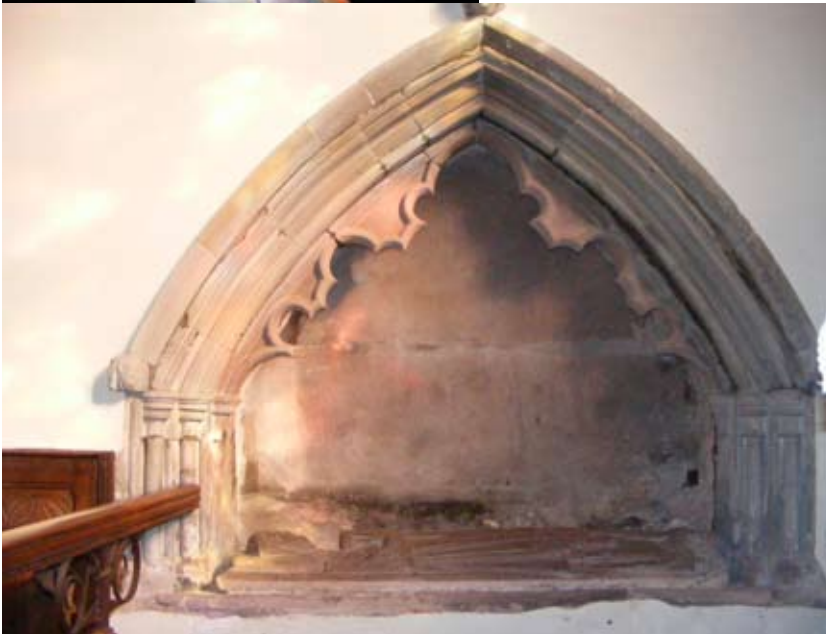
▼ **Illus A4.5**

*The 'Heart Tomb' of Clarissa, daughter of John Tregoz*

In the north wall of the chancel is an effigy reputed to be that of Clarissa, daughter of John Tregoz, Lord of Ewyas Harold (d. c.1300). The effigy contains a small cavity beneath its clasped hands, in which a vessel containing the heart of Clarissa is believed to have been deposited.

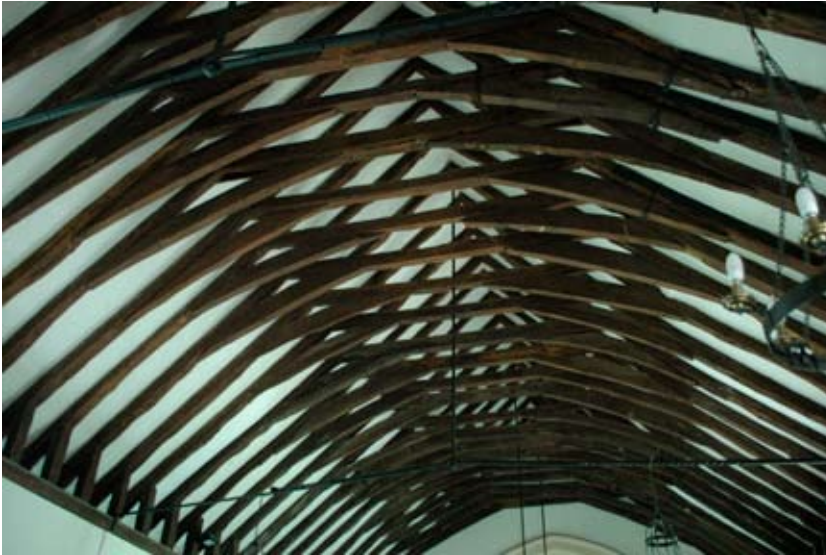
Illus A4.7

*The medieval nave roof*

The nave and the timber-framed south porch are not particularly fine examples of their date but what is unusual is the retention of a medieval close-coupled trussed rafter roof. This appears to be genuine and could date to the 14th or very early 15th century. It presumably belonged to the medieval nave replaced in 1868. The chancel arch, however, appears to be of that date.
