# The History of Ewyas Lacy

**Title:** Digital Archive: Royal Commission on Ancient and Historical Monuments - Photographs of original survey particulars, Part 9 of 13

Part 9: Longtown

1. Name and situation of Monument (with owner's Name and Address). *Oldcourt House*  
*1 3/4 miles N.N.E of Clodock Church.*

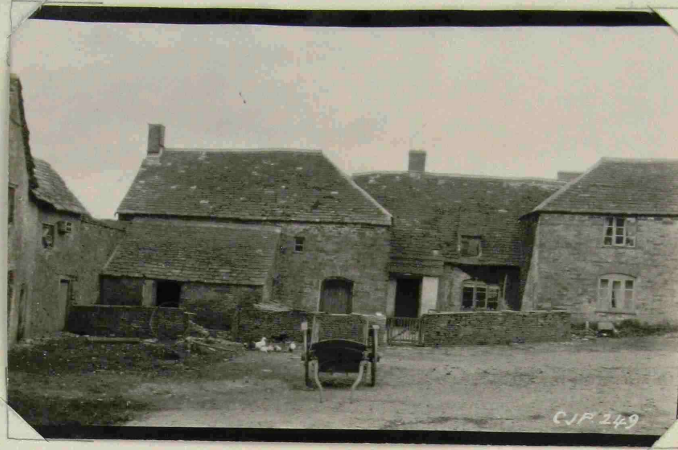
*South Elevation*

5. Elevations: (Beginning with the main front, and mentioning, in the following order:—(a) Walls; (b) Gables; (c) Doors; (d) Windows; (e) Chimneys; (f) Rainwater heads and pipes.)  
*South Elev. Stone rubble. Two projecting wings with roofs hipped at their inner angles. A modern lean-to has been built against W wing. There is a dormer window to main house. Doors round & modern.*  
*North Elev. Stone rubble. Gable at E end with rectangular outside stack with modern brick shaft. West of stack is the hall window consisting of two lights with trefoil heads within a two centred arch & chamfered transome, mullion & cill of ash. The two centred arch head, mullion, transome & cill are all of red sandstone, while the joints are chamfered of rough ashlar of same kind as rubble walls (see also 'internal arrangements'). West of this again is an old battened door hung on strap hinges to a modern frame.*

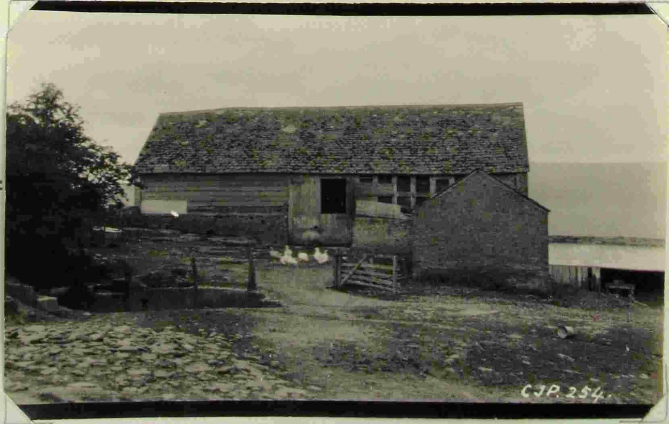
*E. Elev. Timber frame, covered with modern boarding, on stone plinth*  
*W. Elev. As E but N half had had stone wall built up to eaves level to replace timber framing. Actually except for doorway the whole of this elevation is concealed by modern 'lean-to' roofed additions.*  
*S. Elev. Gabled. Re-built stone rubble.*  
*N. Elev. Gabled. Stone rubble, 3 slit windows, two gabled on or ground floor level. Some re-building to this elevation.*

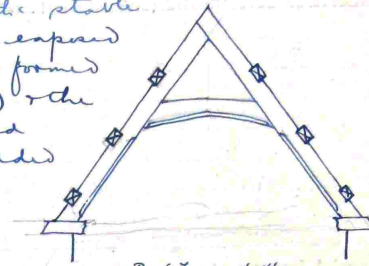
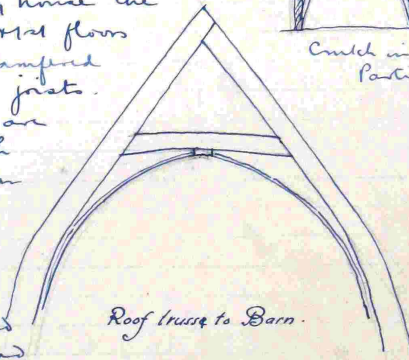
The house would appear to have originally consisted of a hall with open endch. roof with arch braces beneath the collar removed and braces. This hall is now the Barn. At the S.W. end of this what is now the farmhouse was possibly the solar wing & at the opposite end the kitchen would appear to have been replaced by 17th c. stable.

In the Barn (Hall) are 4 exposed endchies two of which were formed partitions (see sketch below) & the central endch was exposed & had arch & carved moulded braces, other exposed panelling round braces.
