## **GREEN COTTAGE Longtown Herefordshire**

**An Archaeological Watching Brief**

Hereford Archaeology Series 336

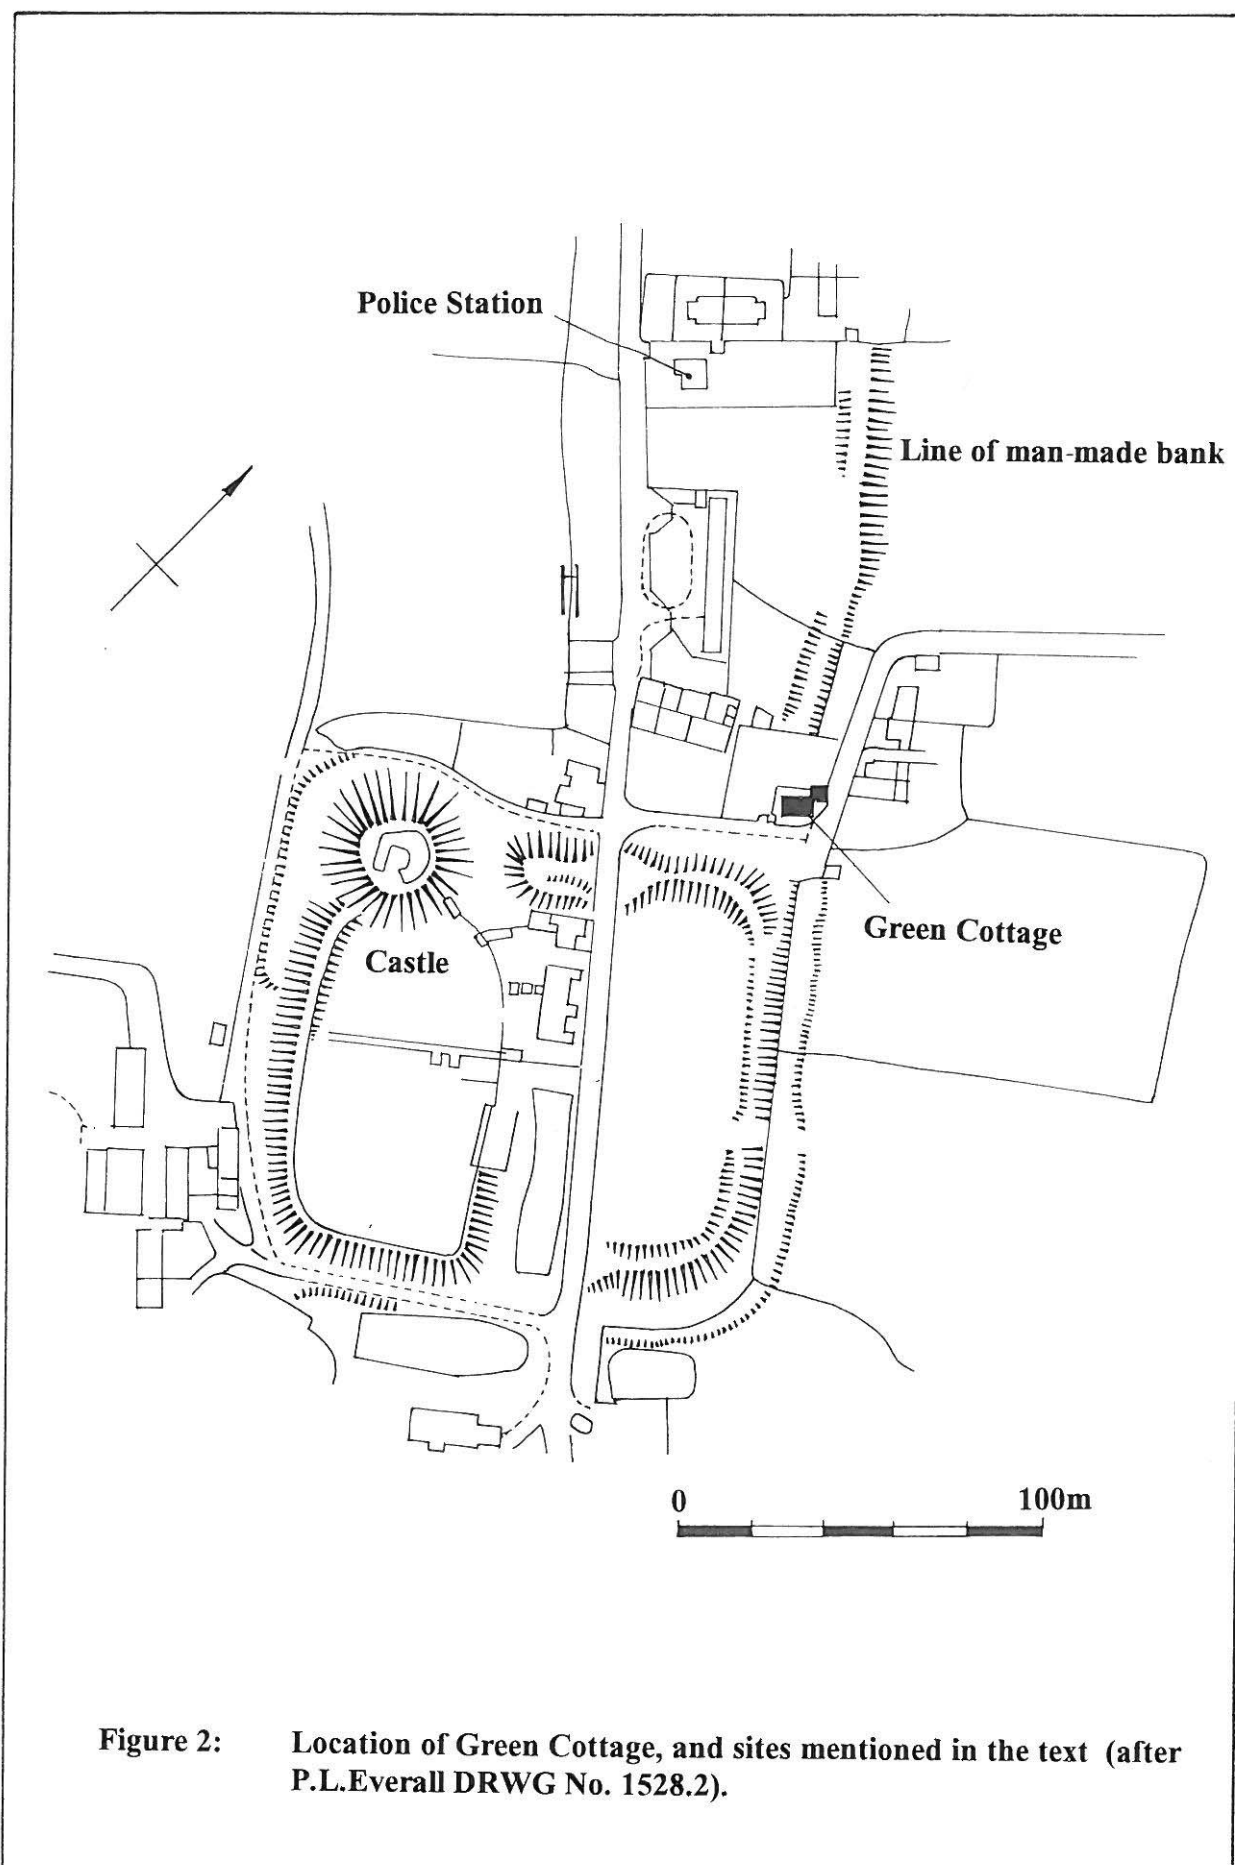
**Figure 2:** Location of Green Cottage, and sites mentioned in the text (after P.L.Everall DRWG No. 1528.2).

Immediately to the north of the cottage grounds are traces of the medieval defensive embankment running in a northern direction (Figure 2, Plate 2). It appears to have been partly cut away on the east to form a car parking area for the Baptist Church opposite.

To the north of the castle is an earthwork (HWCN 21945, Figure 2, Plate 2) indicating a defended area (seen to the south of the development area as HWCN 21946, Figure 2), and it is a trench through these earthworks that is the subject of this report. The development area lies outside the scheduled area (SAM HW20) which is situated both to the north and south. This area is considered by some to be a fourth bailey of the castle. However, whatever its original function, it contained buried remains of 12th and 13th century house platforms and associated features, as identified by previous excavation, (HWCN 19470; HWCN 22005, Taylor and Woodiwiss 1988; HWCN 22008, Brown 1991).

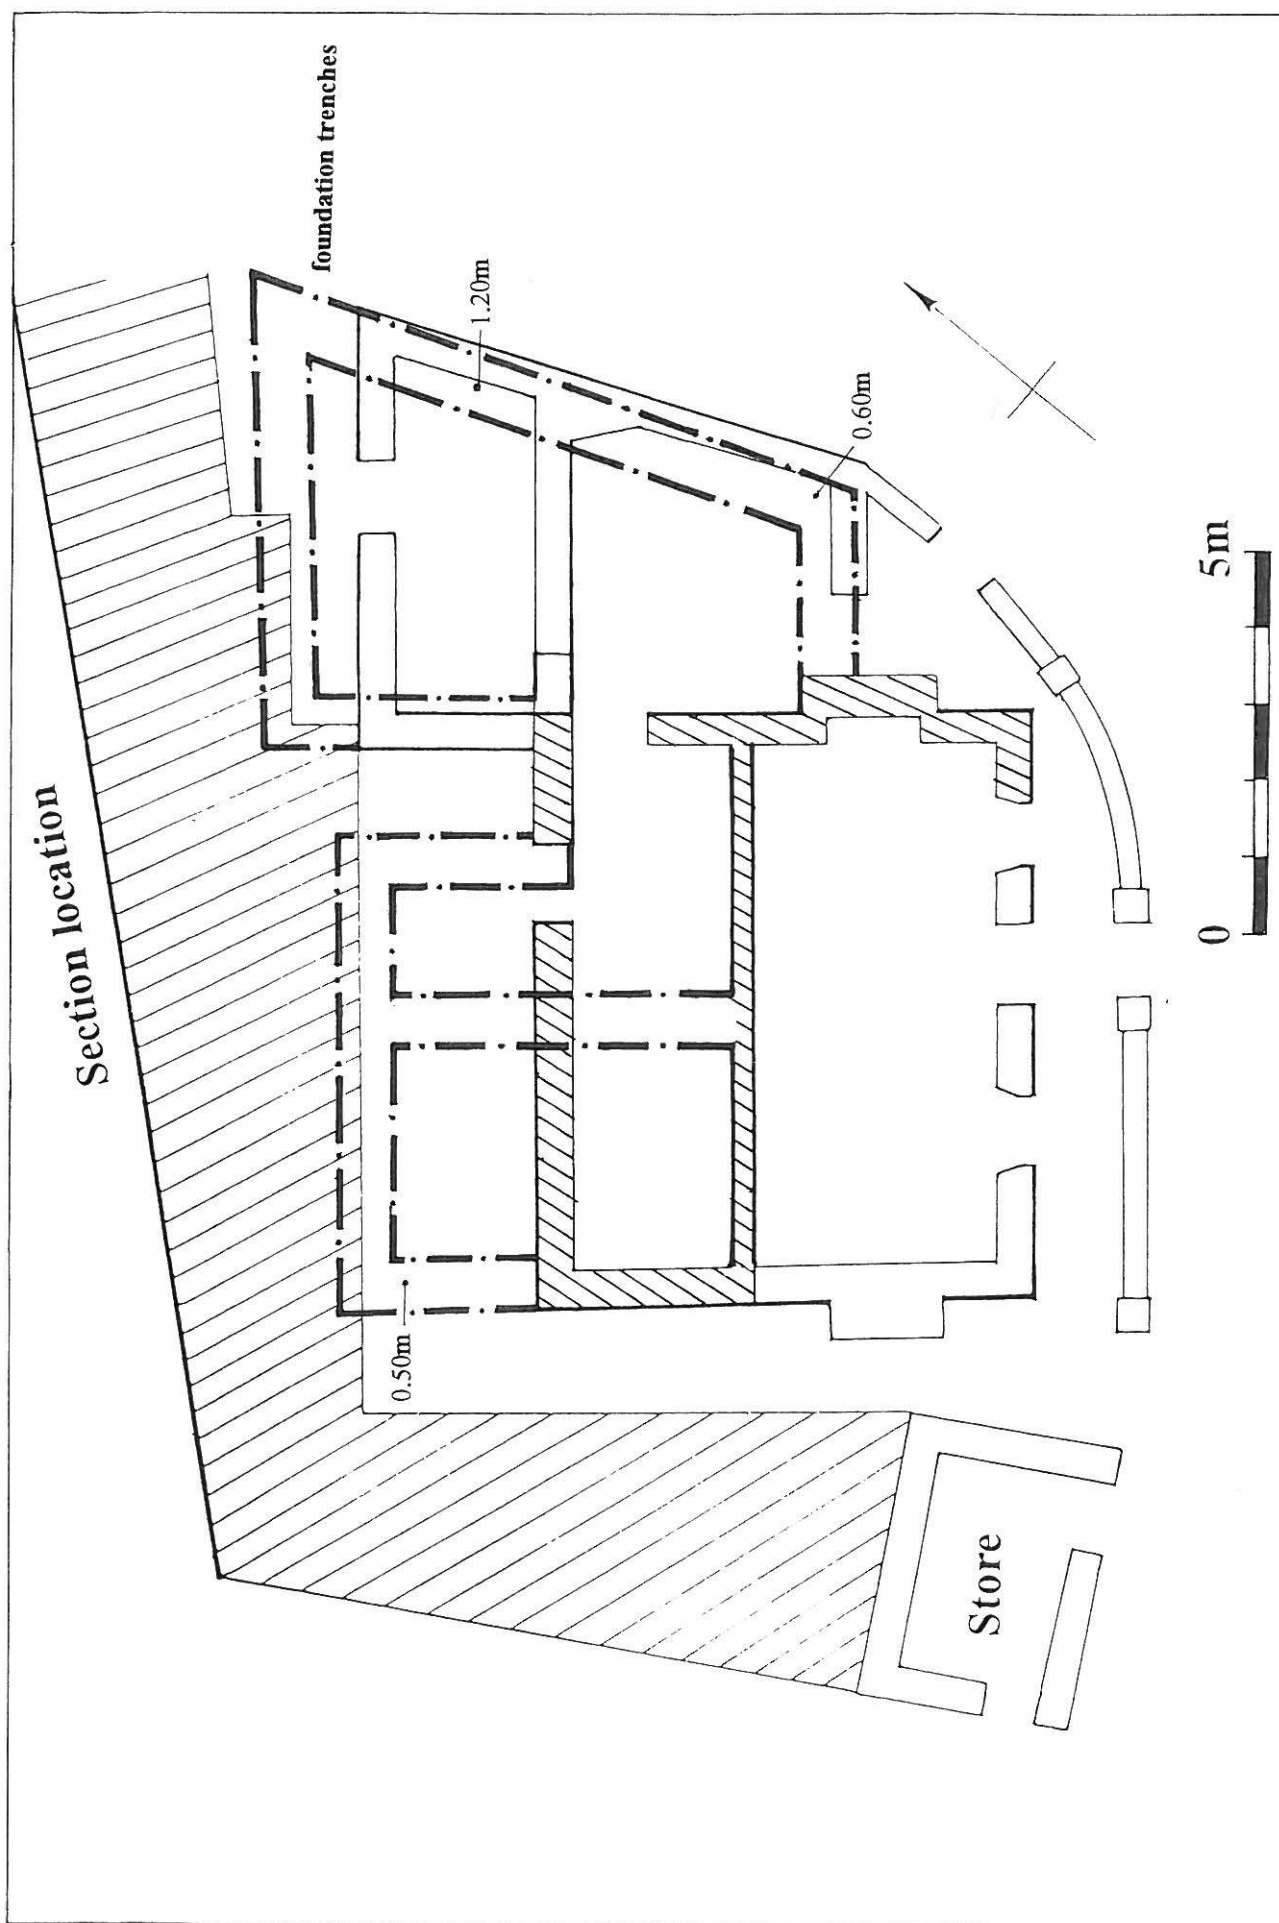
Fig. 3 Excavated area and section (Fig 4 ) location plus position of new foundations as observed.

Further observations of the excavated trenches for the new foundations were carried out (Fig. 3). This was done after the top soil had been stripped so measurements of depth should be taken as being from the base of topsoil.

Natural sandstone was observed at 0.25m-0.3m below the base of topsoil. The remainder of the site was relatively sterile with the exception of a modern/Victorian cut observed adjacent to the road on the east side of the site.

The depth of foundation trenches varied from c. 0.5m in the west group of foundations to between 0.6m and 1.2m on the east side near the road.

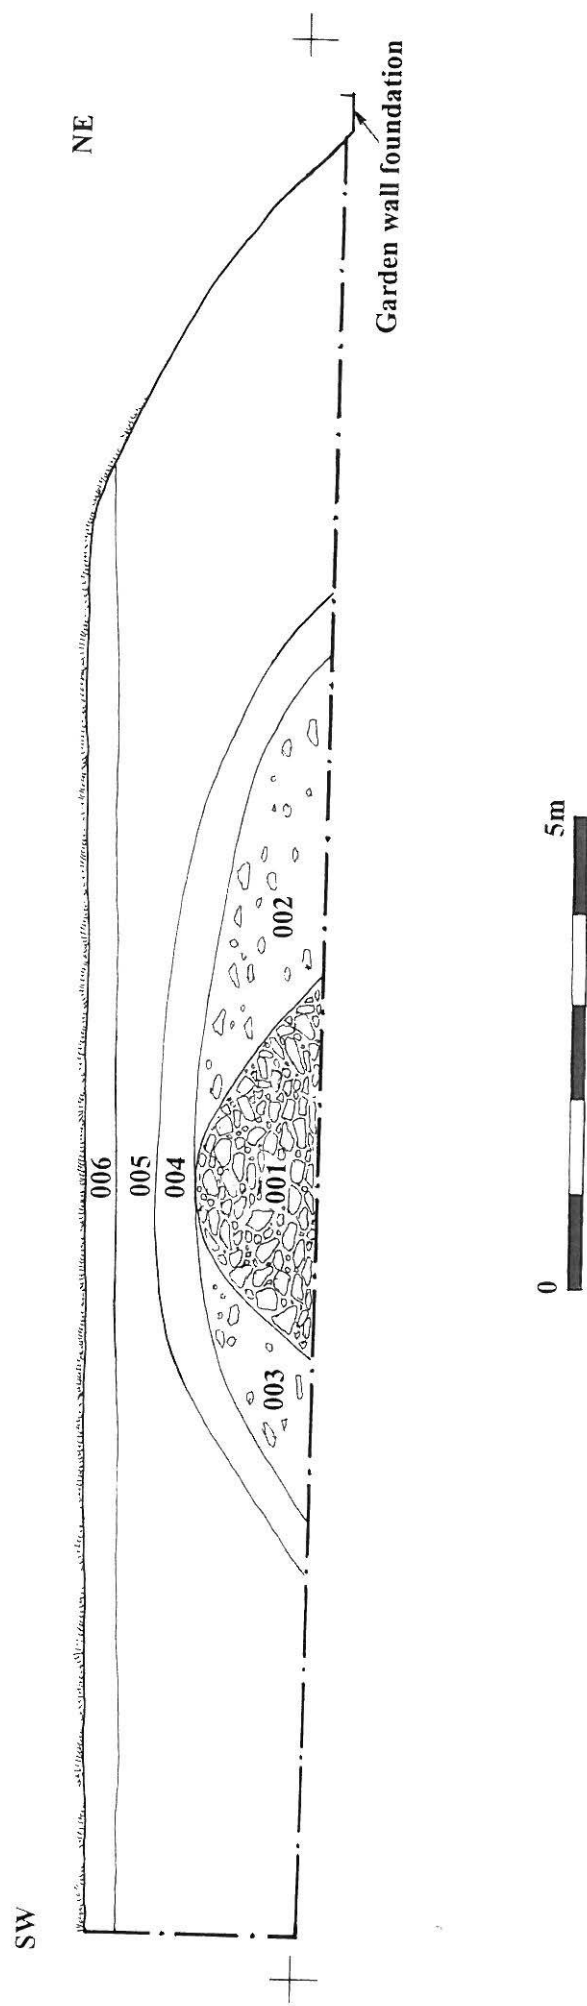
**Figure 4:** The remaining section showing the central core and associated deposits (for location see Figure 3).

The exposed section was aligned south/west - north/east, it measured 17.5m in length, and stood to a maximum height of 1.83m (Figure 3, Plate 1).

The core (001) had a maximum width of 4m (at the visible base), rising to a dome with a maximum height of 1.20m, and consisted of a substantial quantity of green sandstone in a matrix of stained green stiff clay. This was butted on the north east side (i.e. exterior) by a light green clay (002). This had a visible base width of 3.5m and culminated at the apex of 001. To the Southwest of 001 (i.e. interior) was 003, a band of dark red/brown clay loam (re-deposited subsoil) with an abundance of small-medium angular stones. Overlying 001, 002 and 003 was 004, a 0.37m band of gritty red clay loam, that in turn was overlain by 005. This was

evident along the whole of the excavated section and varied in height from 2.12m Southwest and Northeast of the bank, to 0.30m at the apex of the bank. This was then overlain by a band of modern topsoil (006), 0.25m thick, that was stained/burnt mainly black.
