Grove Cottage Walterstone Common, Herefordshire.

A report on evaluation and watching briefs.

Hereford Archaeology Series 553

A report on the watching brief.

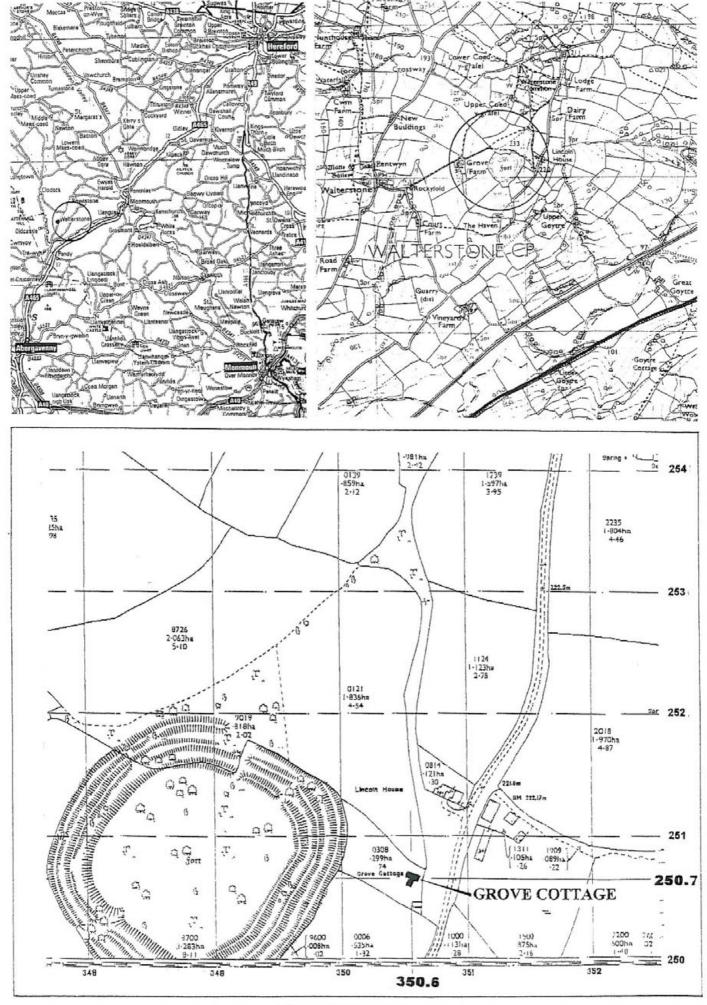
Fig. 2 Trench location plan

Trenches and excavations were located in relation to the main cottage building.

The evaluation trench was located to the north of the main cottage building within the garden area aligned to pick up a boundary. Its westernmost point was located 7 m to the northwest of the northern corner of the existing house. The easternmost corner was located 6m north of the northern corner of the existing house. The trench was 8 m in length and 0.6 m wide and was excavated to a depth of 0.8 m below present ground level.

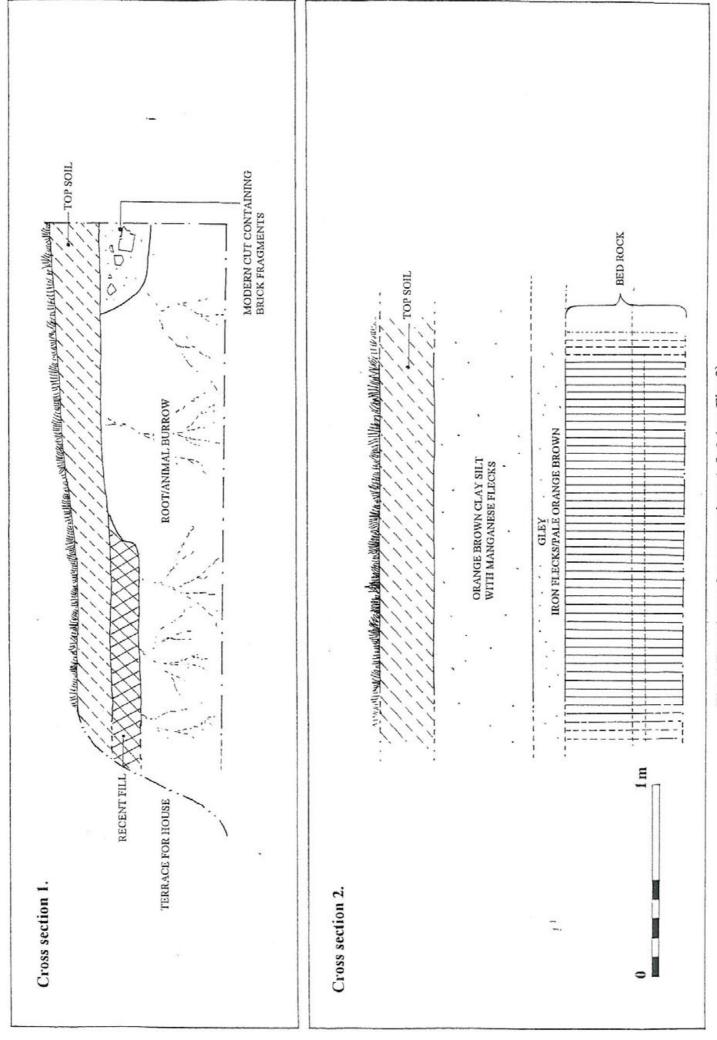
Fig. 4 Drawings of cross sections 1 & 2 (see Fig. 2)

The excavation area was of a square plan 3m wide by 4m long with an orientation of northwest – southeast. A layer of topsoil 0.2m in depth covered the surface of the excavation area. This was a well defined layer with grass roots running through its entirety. The topsoil was dark brown in colour with small stony inclusions making up less than 20 percent of the context.

Below the topsoil a modern cut, cut 1, was identified to the east of the trench. This was close to the main building and contained a recent, loose fill of dark brown matrix and modern debris. This extended 0.15 m below the base of the topsoil and extended to the west 1.2 m.

Also below the topsoil to the western edge of the patio excavation a second modern cut can be seen. This second cut is a flat based pit with steep sloping sides filled with a dark brown fill, builder's debris and modern rubbish. The cut extends 0.5 m east from the western corner of the excavation. The base of the cut is 0.3m below the base of the topsoil.

Both cuts, 1 and 2, are cut into the natural orange brown clay silt deposit, which the topsoil also sits above. This natural clay was a clean sterile layer that showed some root activity and animal burrows. The top of this deposit was directly below the topsoil at 0.2 m below present ground level and extended beyond the base of the trench that lay at a depth of 1 m below present ground level.

The excavated area was 4 m wide by 5m long and had an orientation of northwest – southeast. A layer of topsoil covered the area to be excavated and had a depth of 0.3m below present

ground level. The context comprised a dark brown loose humic matrix with some small stony inclusions and grass roots throughout.

Below the topsoil lay the natural deposit of orange brown clay silt with some manganese flecks. This natural deposit continued to a depth of 0.8m below present ground level.

A narrow layer of gley, 0.18 m in depth, lay below the orange brown clay silt. This context contained some iron flecks of a pale orange brown colour. This gley sat directly on top of the local bedrock, Old Red Sandstone.

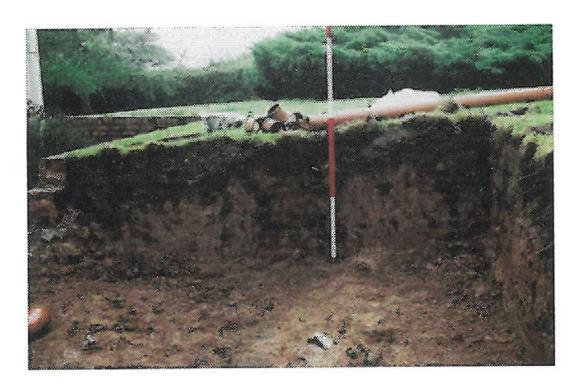
Plate. 1 Northeast facing section of cross section 1

7.1. Part 1. Patio area. (Fig. 2, Fig. 4 cross section 1 & Plate. 1)

The patio area is located to the southwest of the main cottage butting the original patio area and cut into the sloped grass area of the garden to the west of the main building. The trench was excavated to a depth of 1 m below present ground level at its westernmost corner.

Both cuts are modern features and as show no archaeological significance.

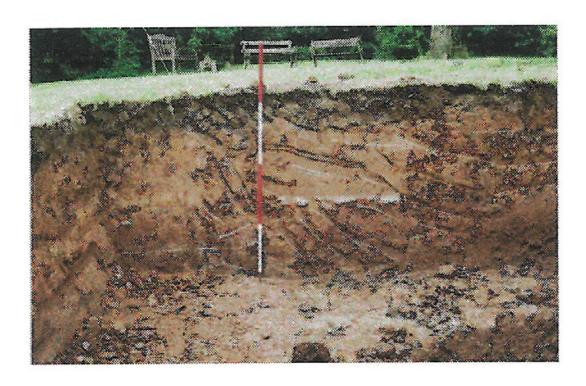
Plate. 2 Southeast facing section of cross section 2

7.2. Part 2. Workshop area. (Fig. 2, Fig. 4 cross section 2 & Plate. 2)

The workshop excavation area was located to the west of the main building and north of the new patio area. This butted up against the existing building and the excavation for the patio area. The trench was excavated to a depth of 1.6m below present ground level at its westernmost corner.

No archaeological features were identified in this excavation area.

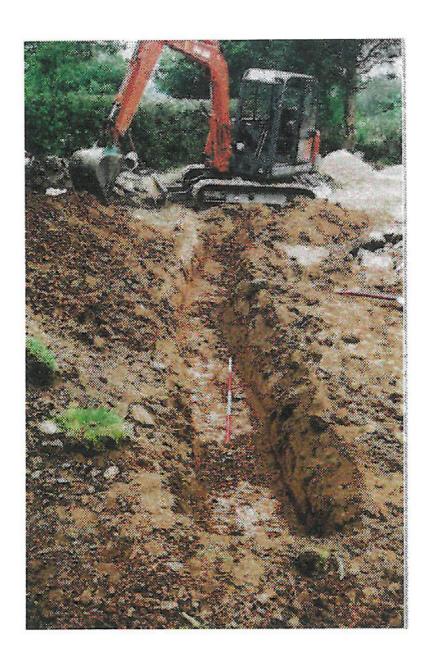
Plate. 3 Evaluation trench

7.3. Part 3. Evaluation trench. (Fig. 2 & Plate. 3)

The top of the trench was covered by a thin layer of topsoil 0.2m in depth. This topsoil was dark brown in colour and contained small stony inclusions and grass roots.

Below this topsoil natural orange brown clay silt was identified. This context was clean and sterile only containing some manganese flecks and extended down below the depth of the trench at 0.8m in depth.

No archaeological features were identified within the evaluation trench.
